Mining
Remediation
Authority

Coalsnaughton community update

2 June 2026

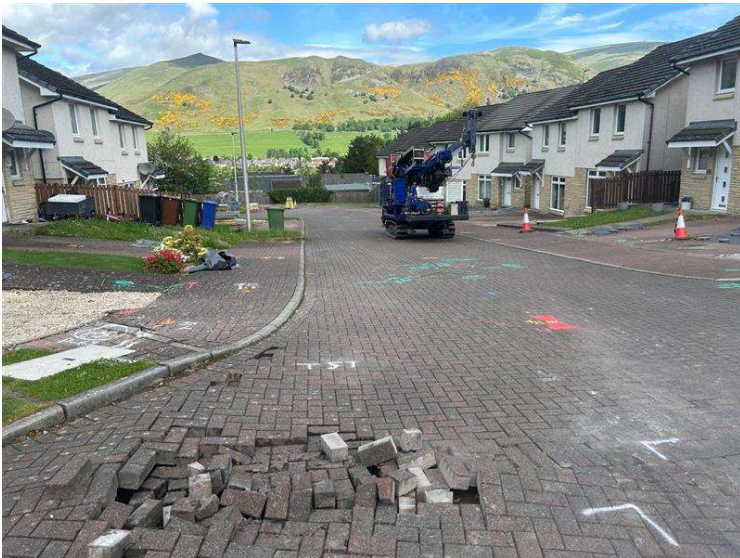
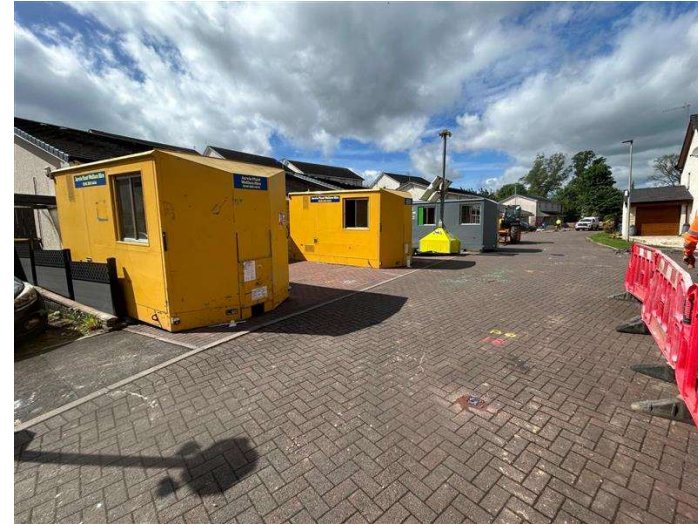
Ground movement was reported at Benbuck View from 18 May

Properties were evacuated as a precaution as the situation developed – services then disconnected

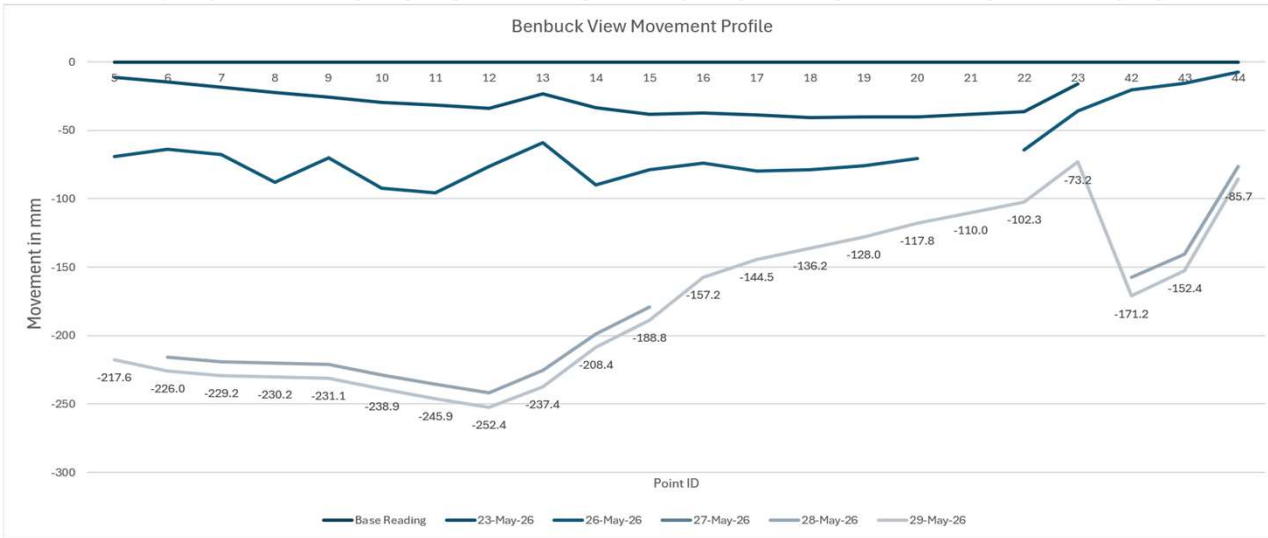
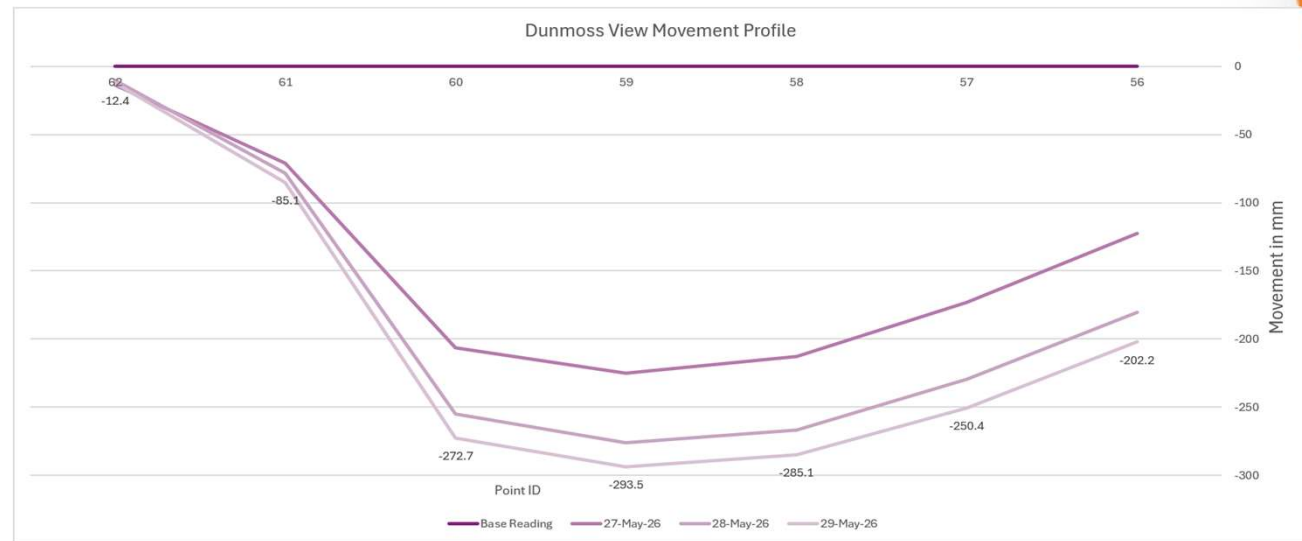
What movement the monitoring is showing

Benbuck
280mm recorded movement
Currently moving 5-10mm/day

Dunmoss
Over 300mm total movement
Currently moving 10 - 15mm/day

The Glen
190mm total movement (one point)
Currently moving 10 - 15mm/day

Nechtan / Langour
No movement
