Mining
Remediation
Authority

Coalsnaughton community update

2 June 2026

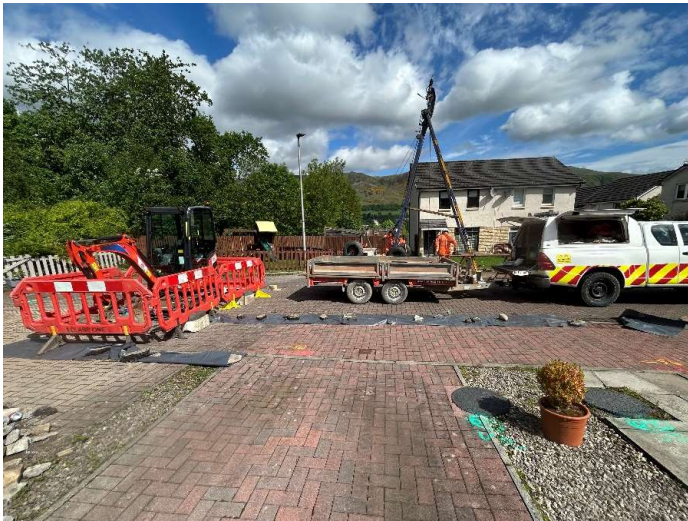
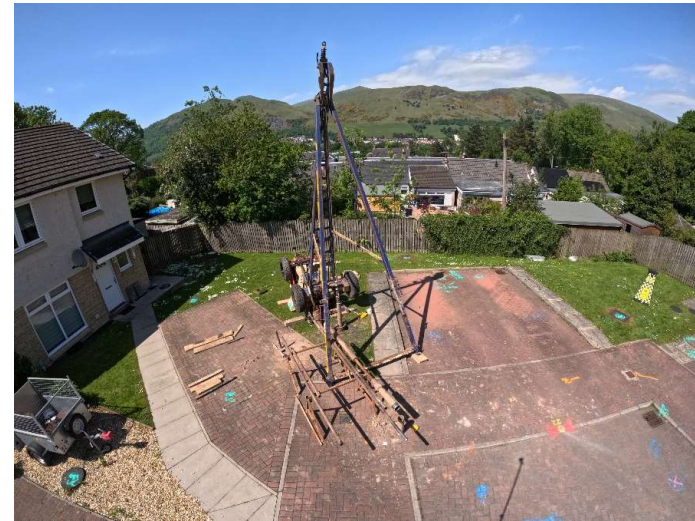
Used specialist techniques (including laser scans / drone surveys) to track movement

Ground investigations ongoing, including drilling, to understand full extent of ground conditions

Survey markers and monitoring equipment installed across Benbuck and now extended into the surrounding streets

Movement is ongoing - we don't yet know the cause of movement, our investigations are trying to establish this

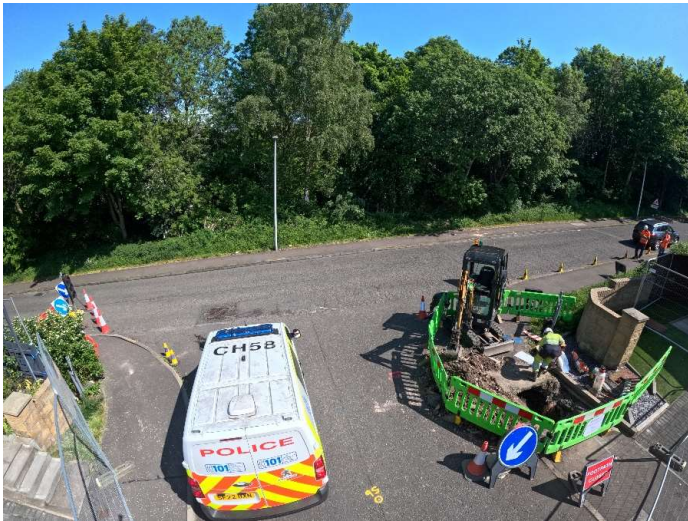
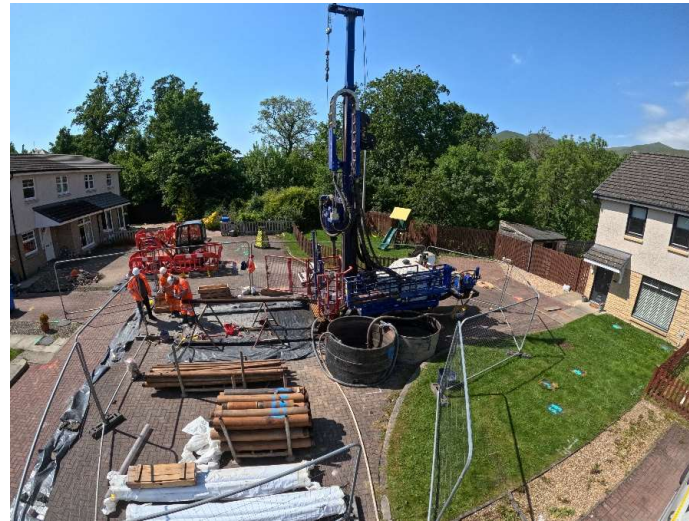
Site expanded to include all impacted streets

Security fencing, CCTV and access controls in place

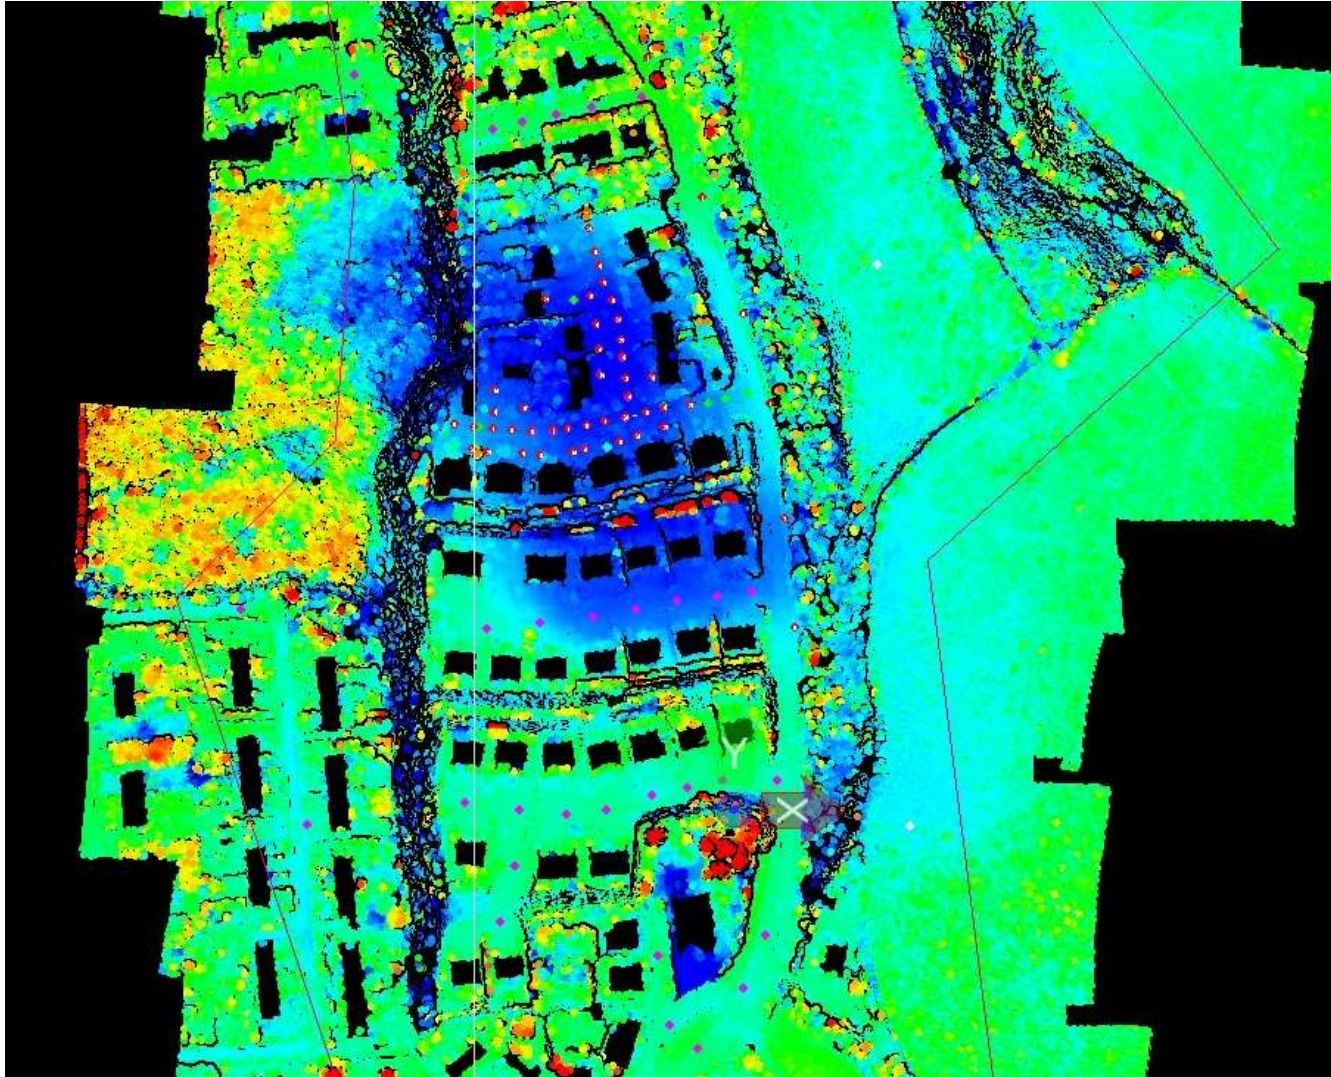
What movement the monitoring is showing

Benbuck
280mm recorded movement
Currently moving 5-10mm/day

Dunmoss
Over 300mm total movement
Currently moving 10 - 15mm/day

The Glen
190mm total movement (one point)
Currently moving 10 - 15mm/day

Nechtan / Langour
No movement
